Portage Creek Sediment Remediation Project Kalamazoo, Michigan

Pre-Sediment Removal Structure Feature Assessment
Removal Areas SA5-Axtell, SA5-D and SA5-C

F&V Project Number: 809930
May, 2012

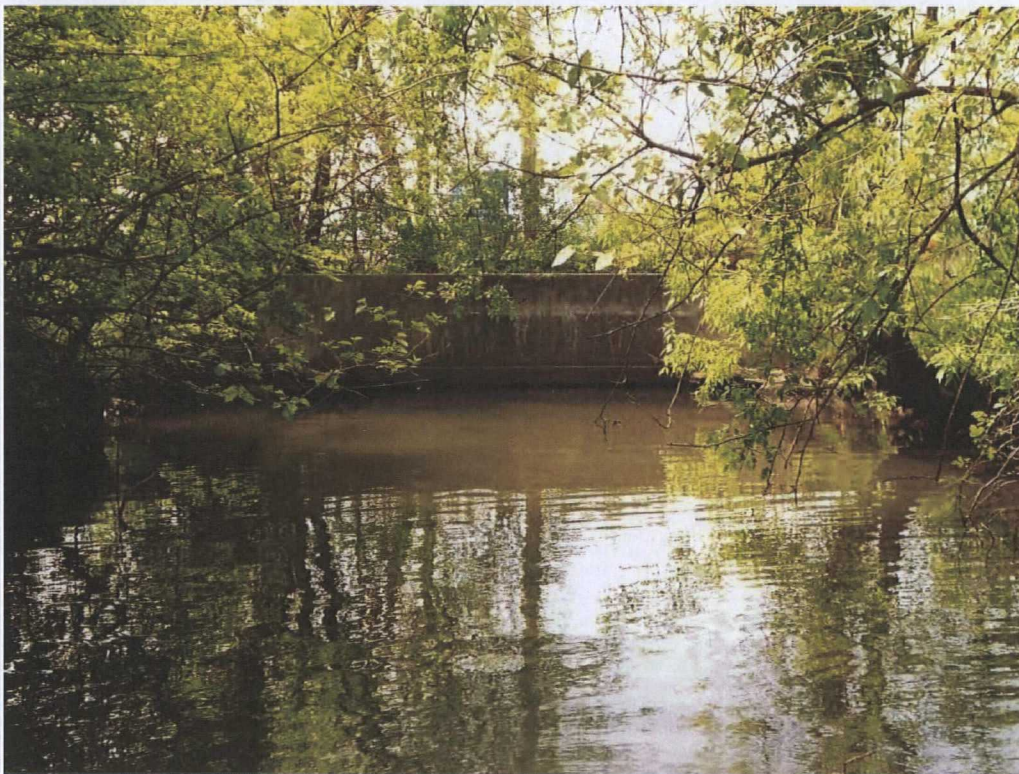
Elevation view of the structure

- To avoid disturbance of the structure during sheet pile installation, it is recommended that the cofferdam be kept approximately 8-10' from the headwall (4-6' from the end of the wingwalls). If excavation is required closer to the structure, a sand bag cofferdam should be considered.

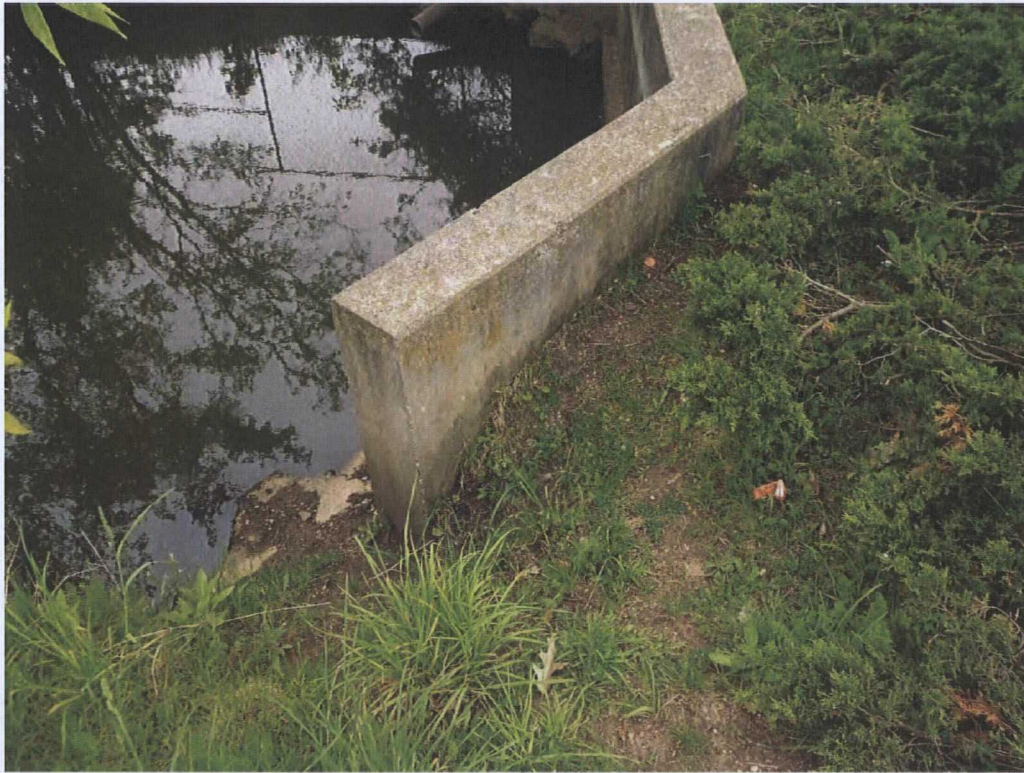
- Moderate slope erosion was noted behind the headwall and wingwalls.
- There is a large plunge pool/scour hole just downstream of the outlet.
- The structure includes a pipe penetration (possibly a storm water force main?) through the south wingwall. The pipe has moderate surface corrosion.
- Although the depth of the channel at the structure makes probing difficult, some slight undermining of the culverts is suspected due to the depth of scour.
- The concrete is in fair condition with no noticeable cracking.
- The concrete slope protection in front of the wingwalls is severely undermined from bank erosion.

Slope erosion behind the north wingwall

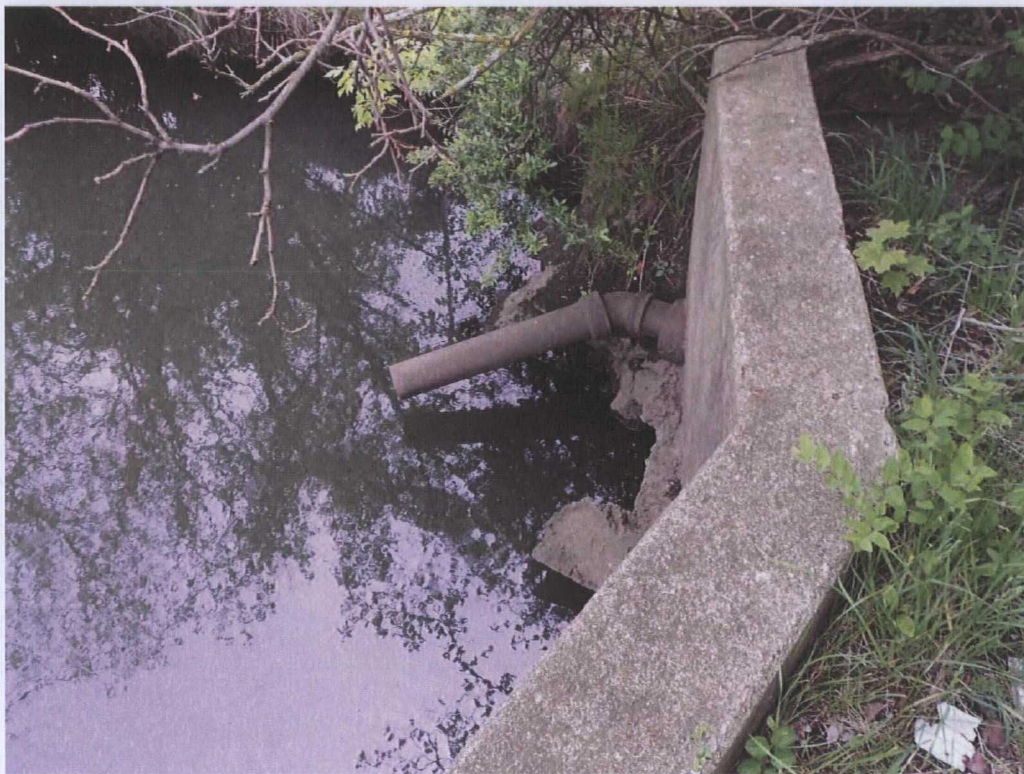
Pipe penetration in south wingwall and undermined concrete

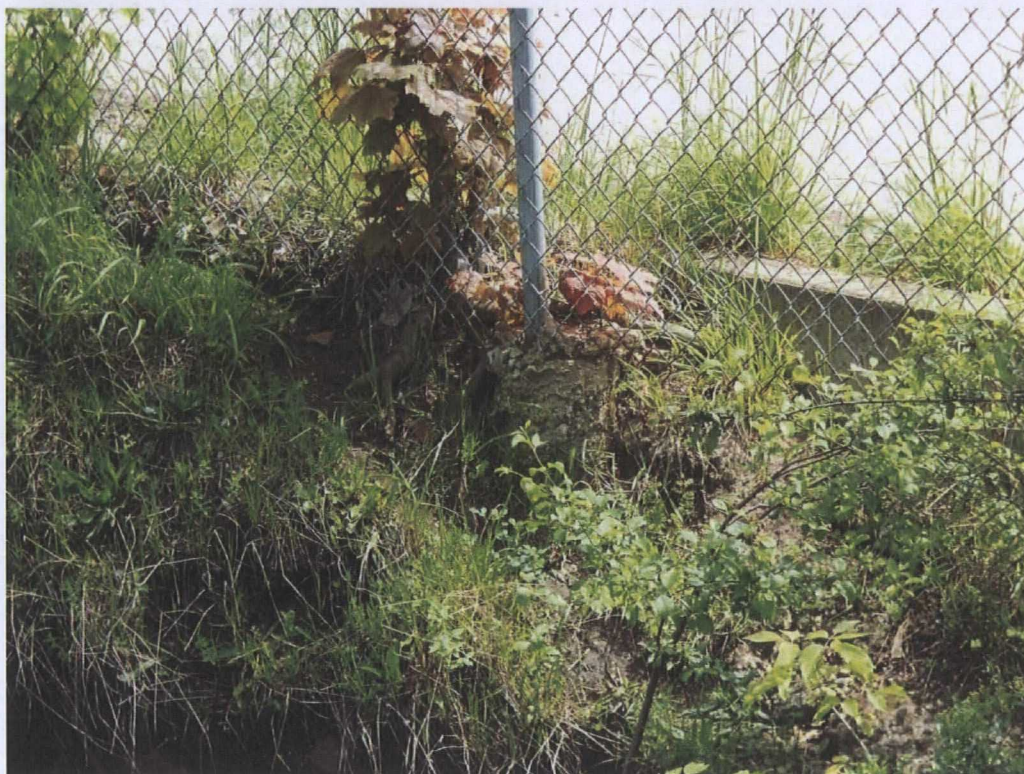
- A portion of the fence along the EQM Primary Support Area had been removed and replaced with construction fencing at the time of evaluation.
- An area of bank erosion has exposed a concrete base just downstream of the outlet structure.
- The fence is overgrown with vegetation in several areas.

Concrete base exposed by bank erosion

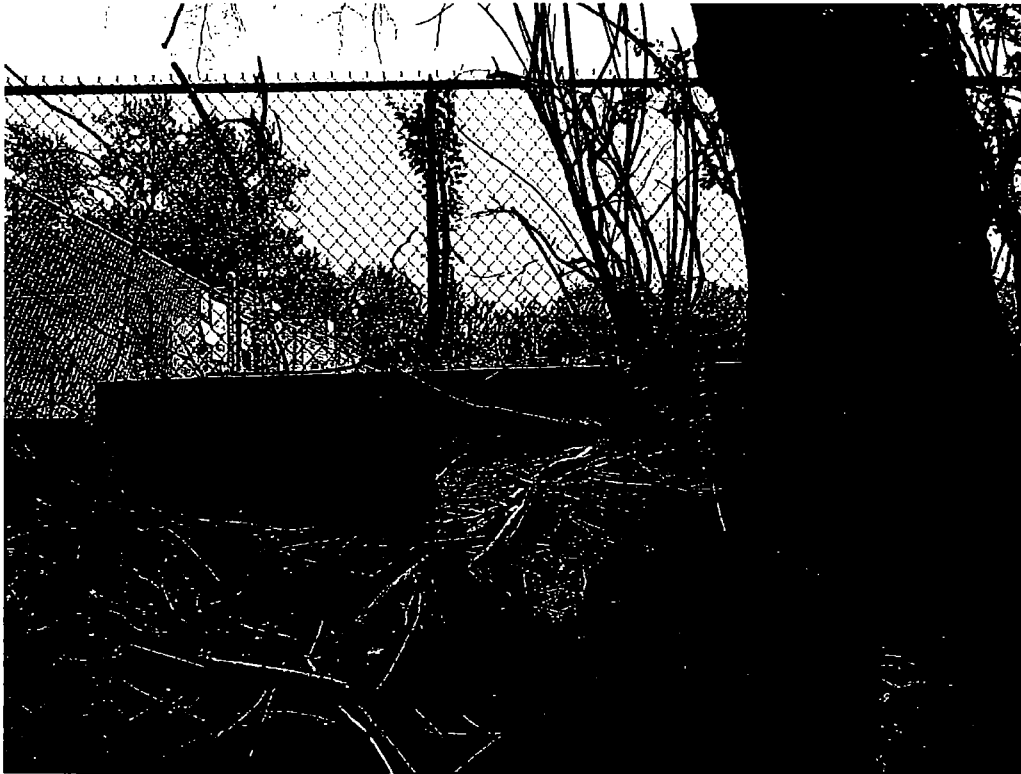
Area of fencing overgrown with vegetation

- Remove the fencing and replace in kind as required to facilitate sediment removal.

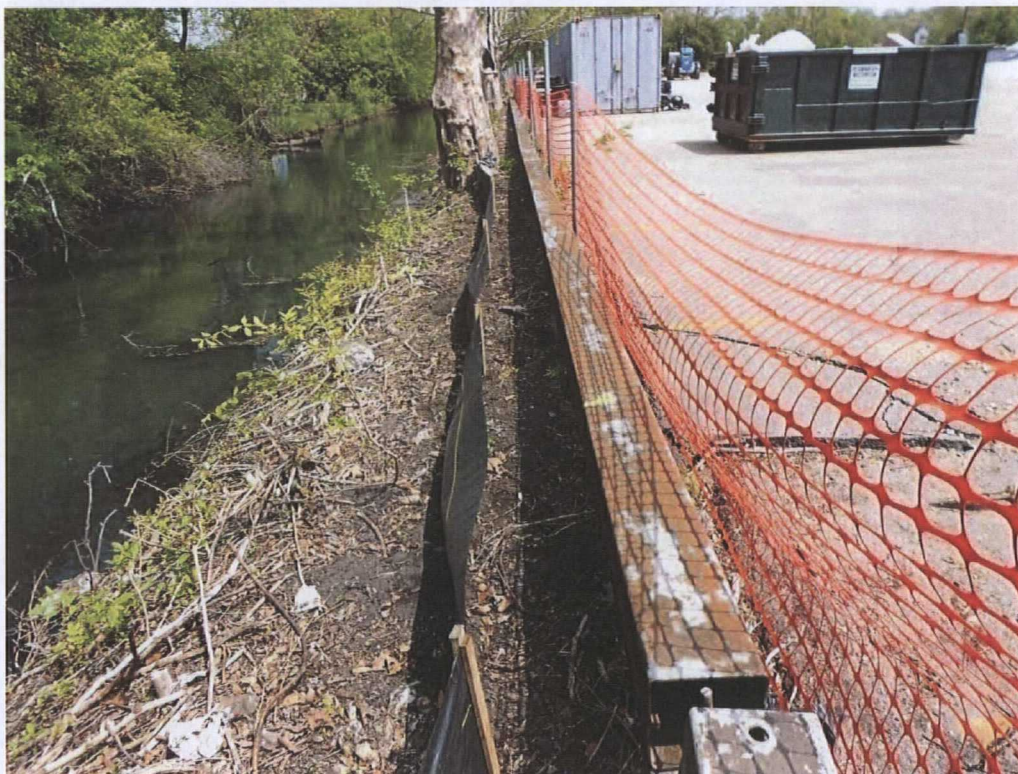
- The steel rail and posts have minor surface corrosion.
- Several posts have been exposed from bank erosion.
- Several rail sections have failed.

View of the rail looking east

- Protect the rail during sediment removal or remove and replace in kind as required.
- Because the parcel is currently vacant, it may be possible to contact the City of Kalamazoo and remove the rail entirely.

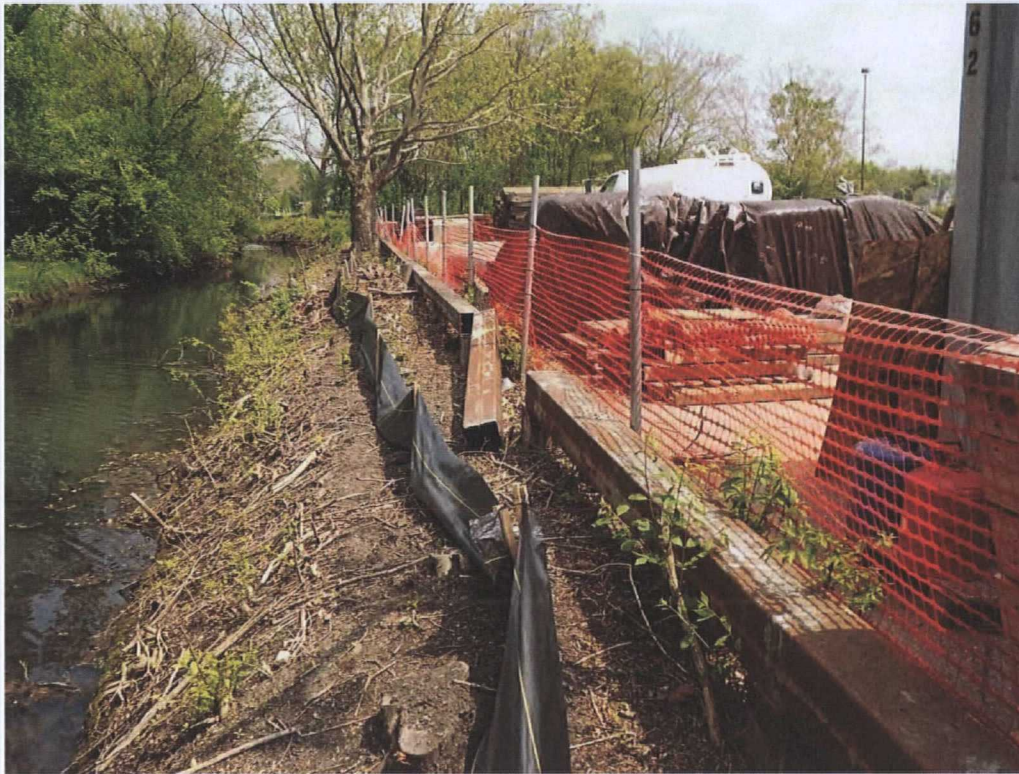
View of the rail looking east

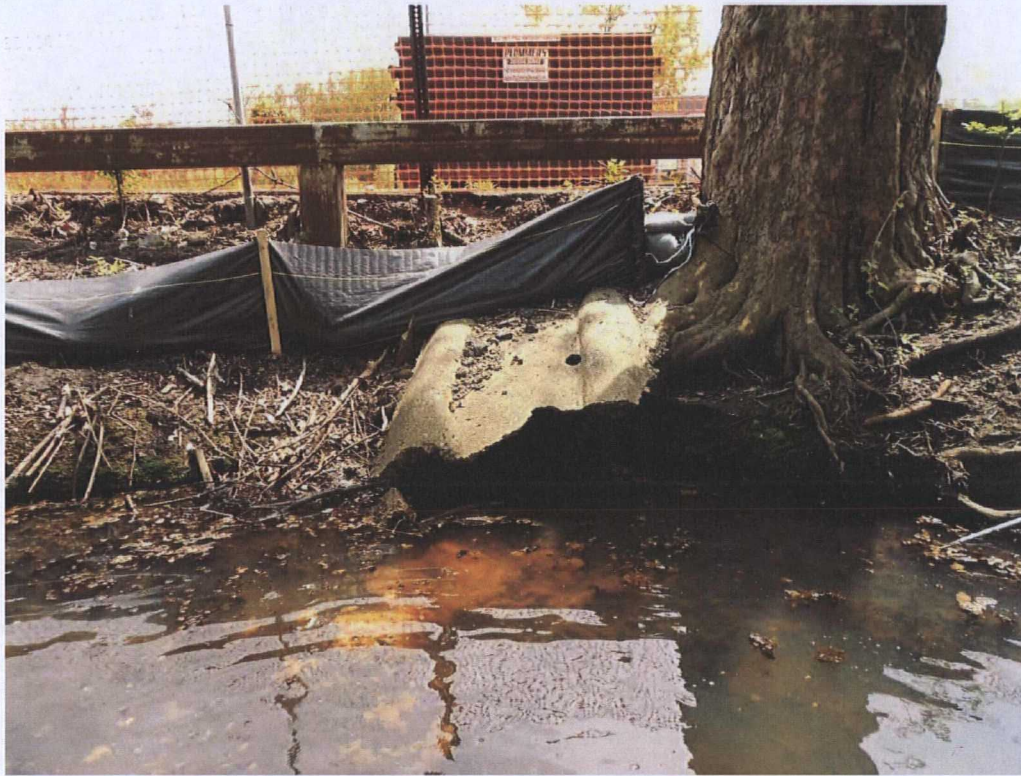
- The spillway has failed from progressed bank erosion and a large tree. Just a portion of the original spillway remains and is no longer connected to the asphalt pavement.
- The spillway is severely undermined and spalled with a hole through the west side.

View of the spillway from the channel

- Because the spillway is no longer functional it can likely be removed and eliminated.

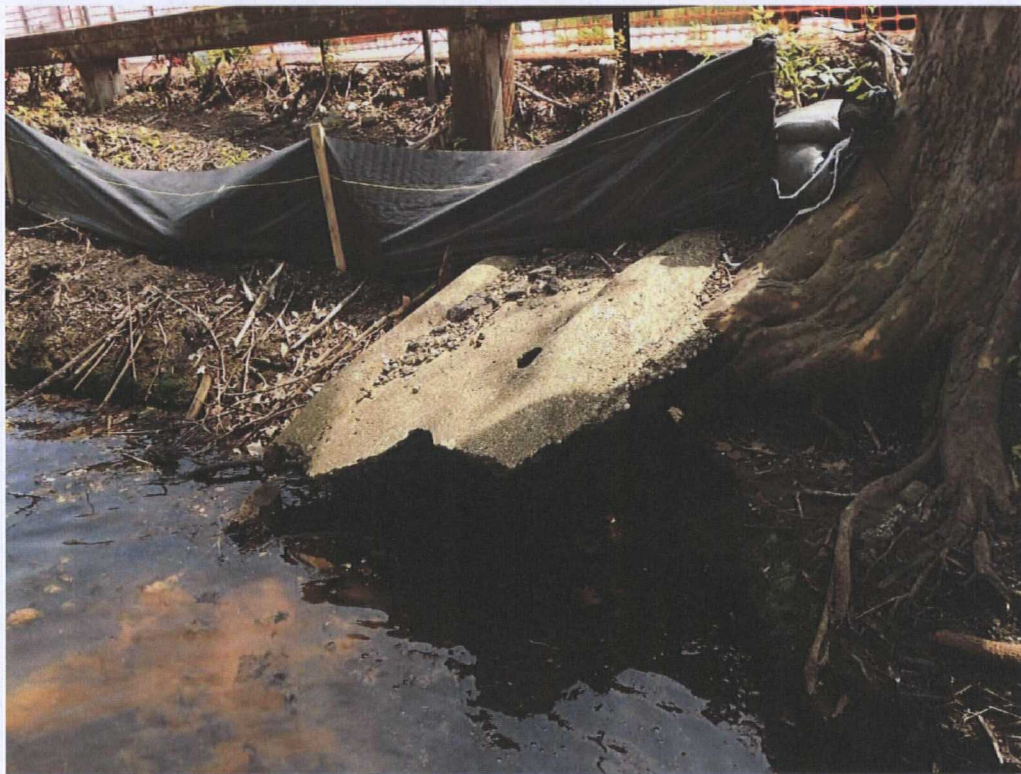
View of the spillway from the upstream channel

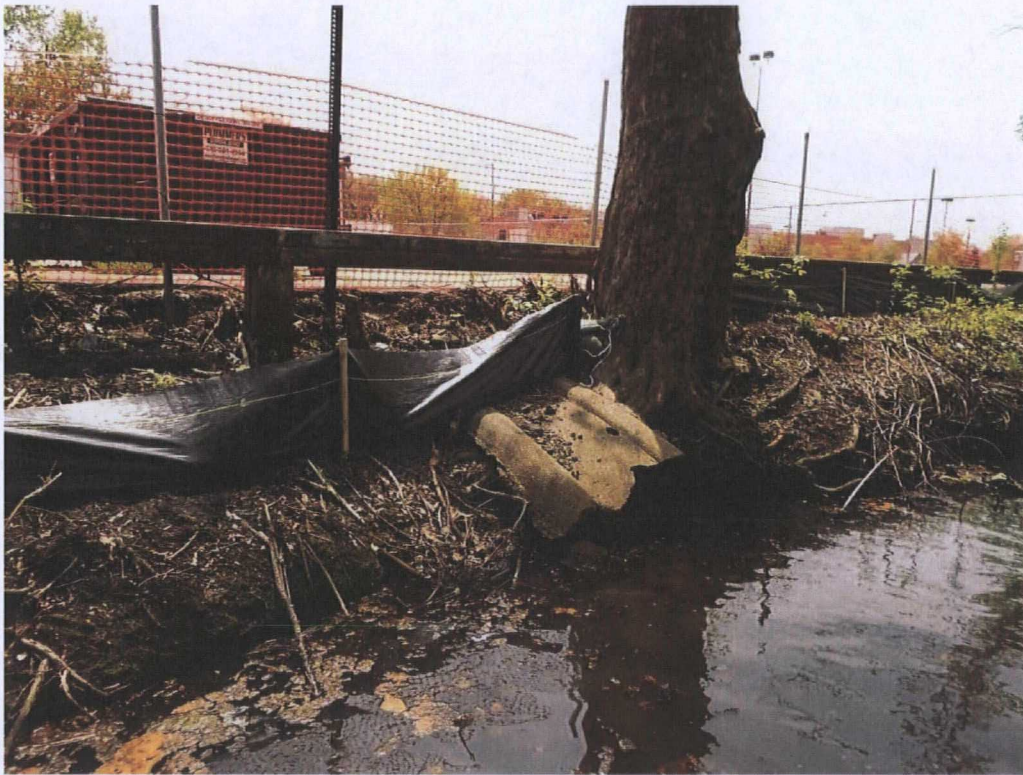
View of the spillway from the downstream channel

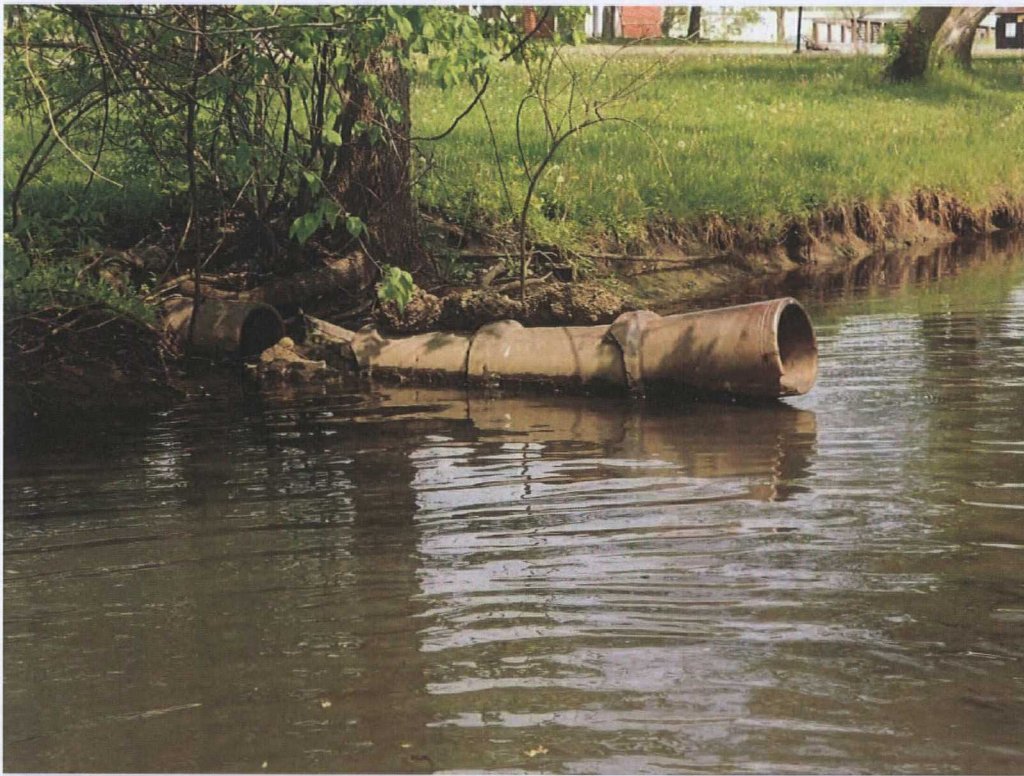
- The last 4 sections of pipe (~8') have failed from severe bank erosion. The bank has cut back ~12-18" on the fifth section.
- There is a sink hole and cracked bell on the 6th section, approximately 4' from the water's edge.

View of the structure from the upstream channel

- Remove the 4 failed sections of pipe in the channel.
- Protect the remaining pipe with an isolation cofferdam to allow for dewatering. Provide approximately 2-3' of clearance between the cofferdam and end of pipe.

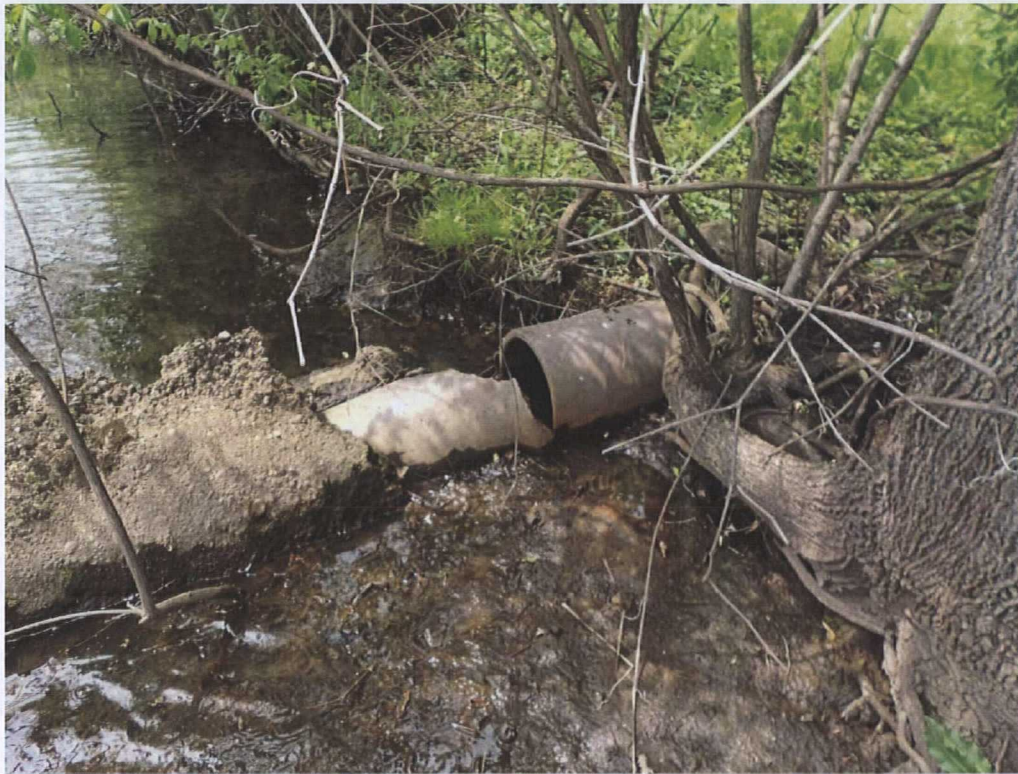
View of the structure from the downstream channel

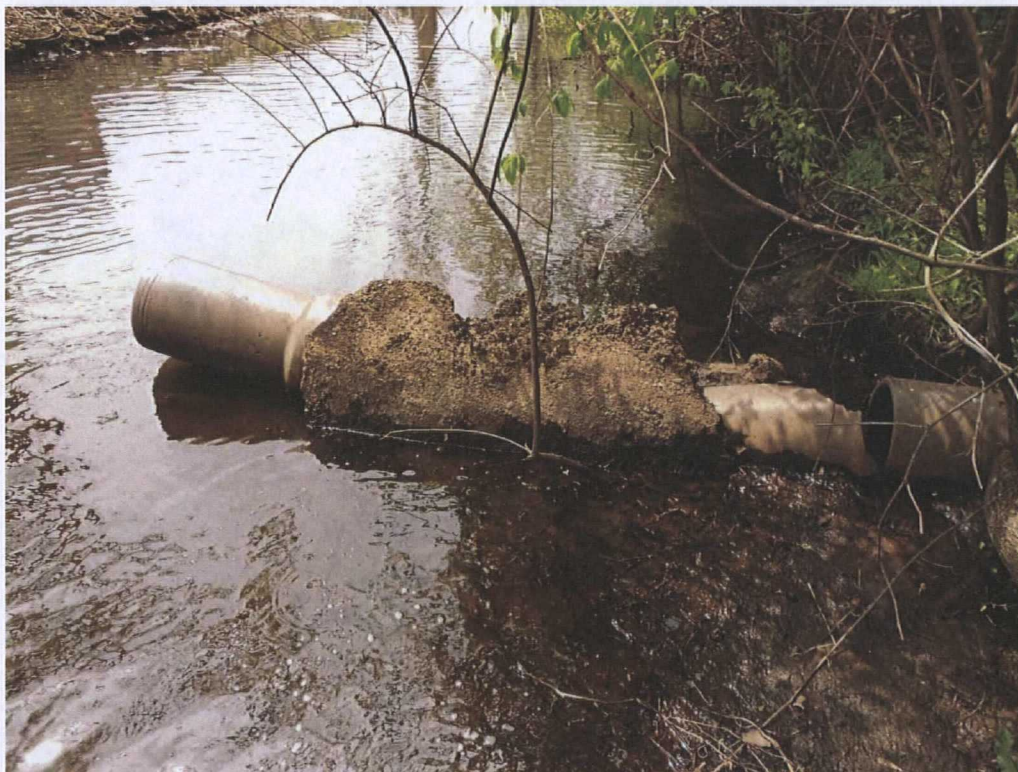
Previous concrete protection on the downstream side of the pipe

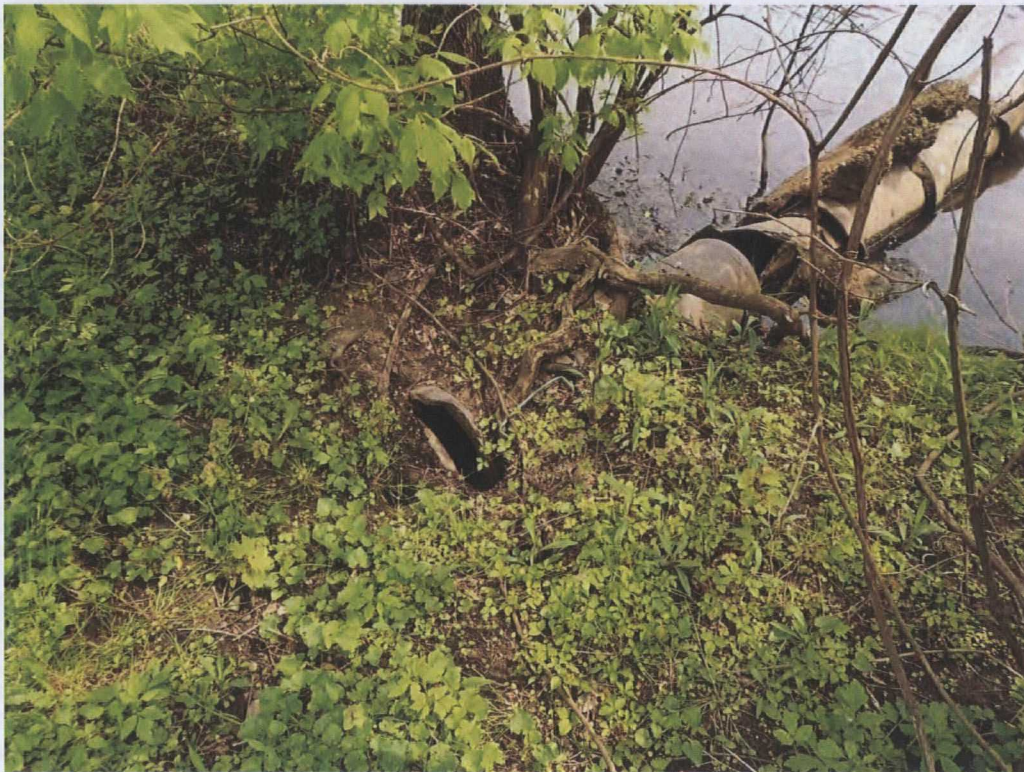
Overall view of structure from bank area

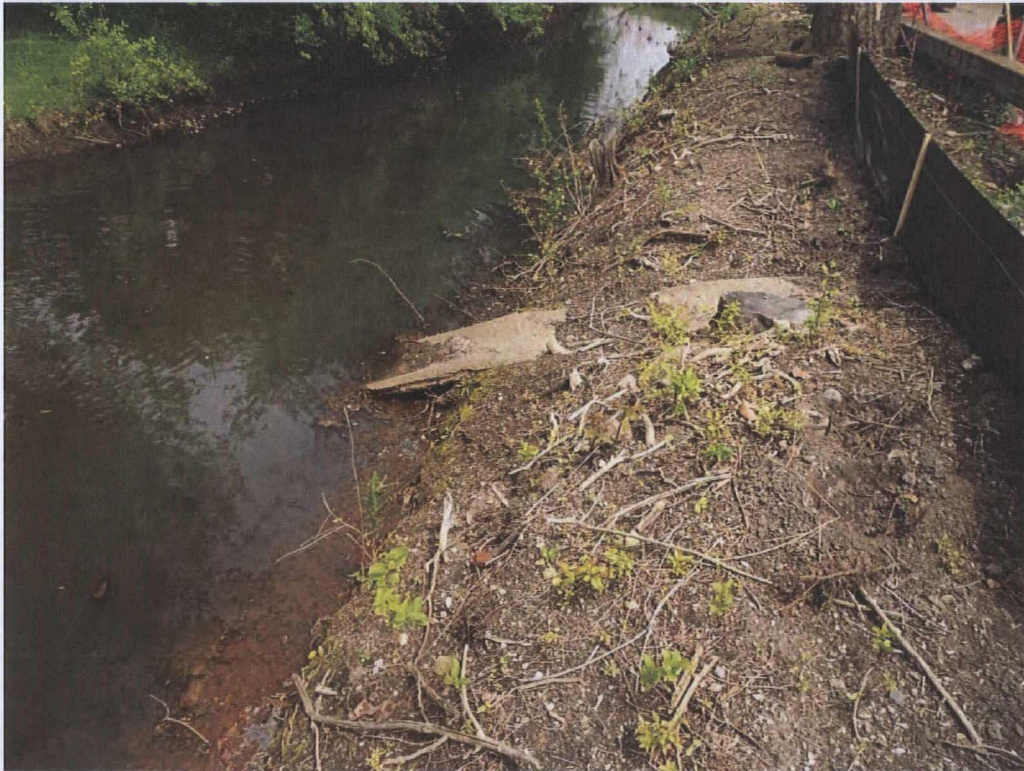
- The structure is in poor condition, nearly failed.
- The end of the spillway is severely undermined from bank erosion.
- The concrete has cracked allowing the end to slough down into the channel area leaving a ~2' gap in paving.

View of the structure from the upstream bank

- Because the spillway no longer appears to be functional, it can likely be removed and eliminated.

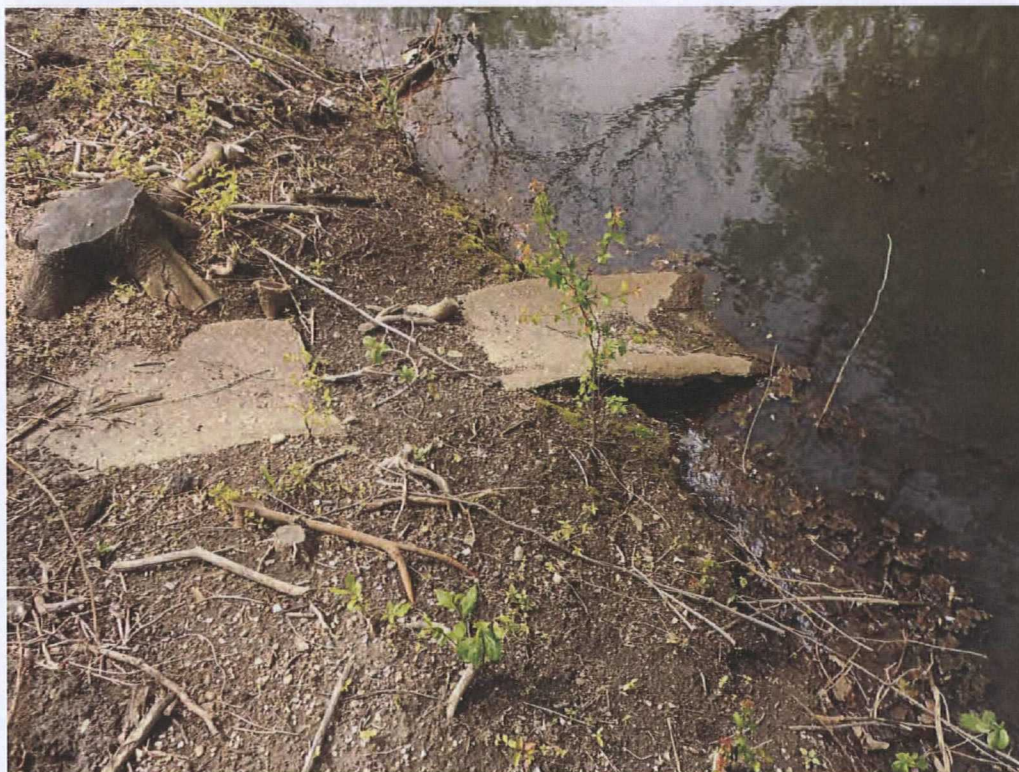
End section sloughed into the channel and undermined

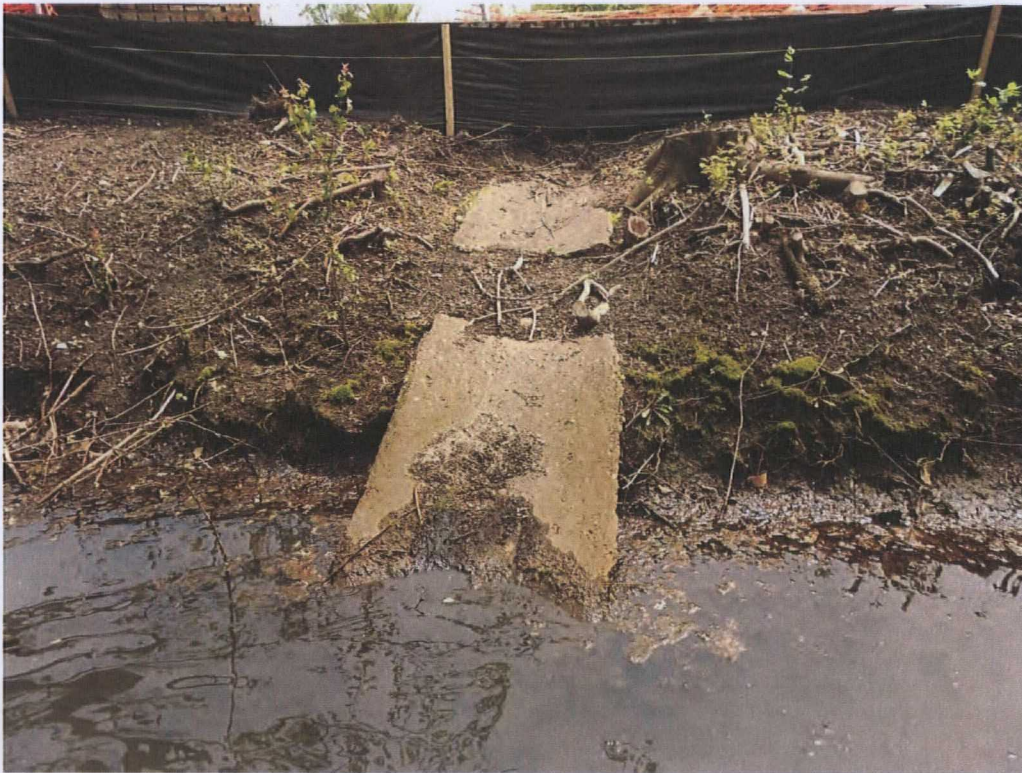
Close-up of structure from channel

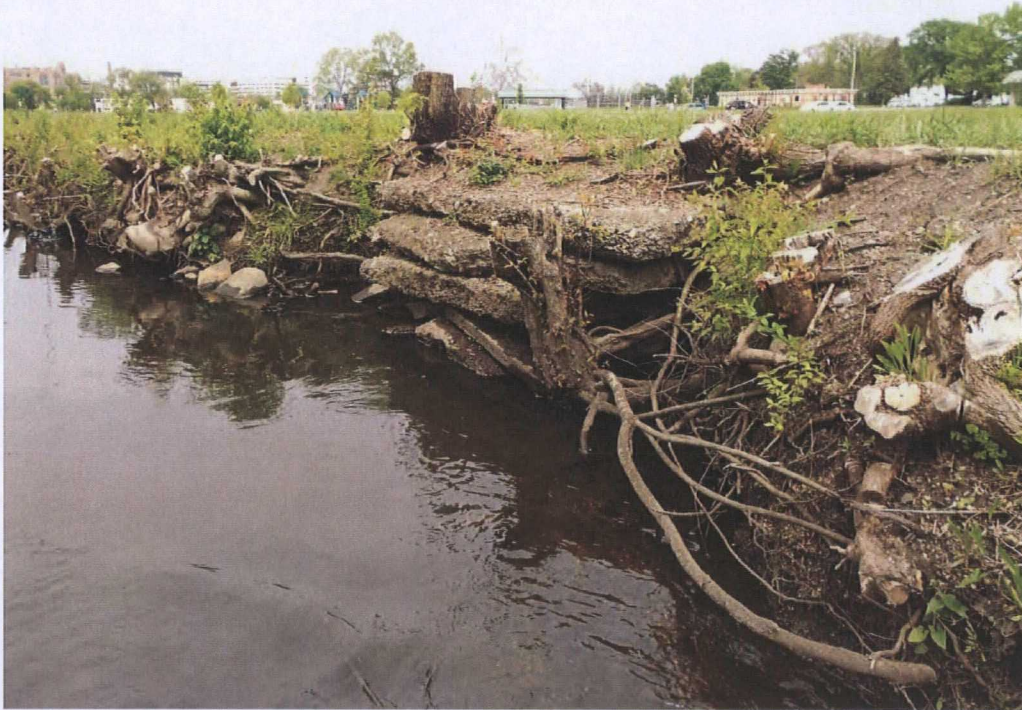
- Several of the slabs are failed or failing from cracking and undermining.
- The structure has severe tree growth and root intrusion, which is causing movement of the slabs.

View of structure from upstream channel

- The structure appears to have been installed to protect an isolated area of excessive bank erosion. Either place a sand bag wall to protect the structure from further undermining or remove it and restore the bank area.

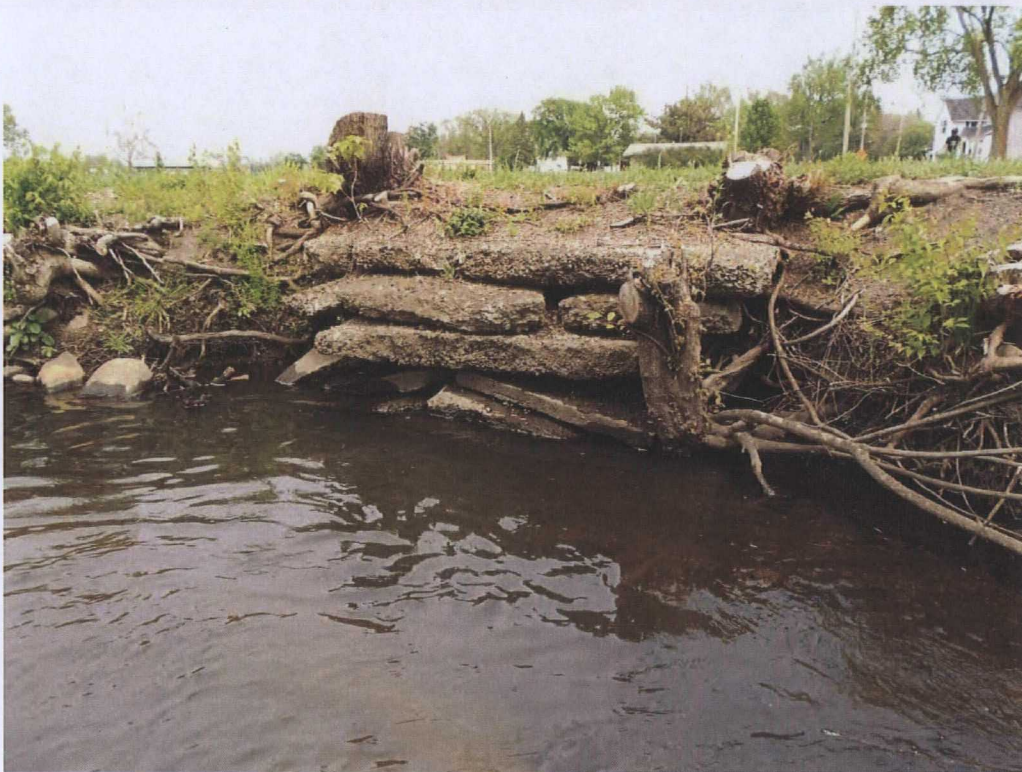
View of structure from channel

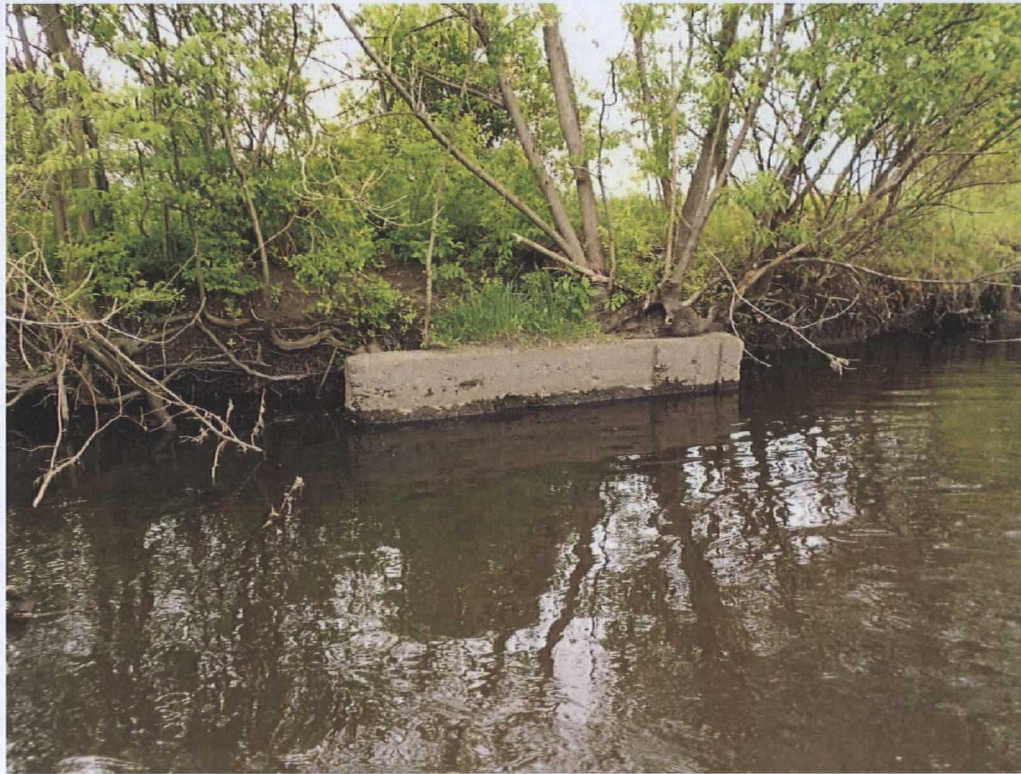
- The bank is severely eroded, approximately 4' behind the wall.
- The wall has severe tree and root growth behind it.
- The concrete surface has moderate abrasion and spalling along the waterline.
- Several sink holes and a partially exposed steel pipe were noted in the bank behind the structure.

View of structure from the channel

- The purpose of the structure is not evident and it no longer appears to be functional. It can likely be removed.

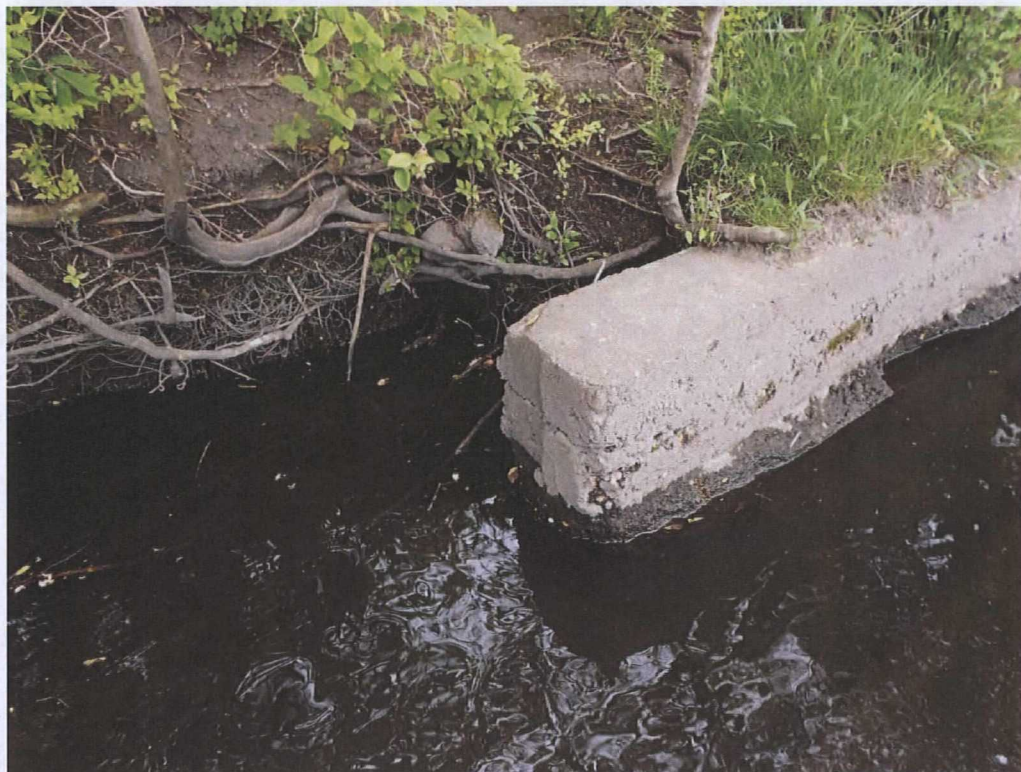
Severe bank erosion around the south end of the wall

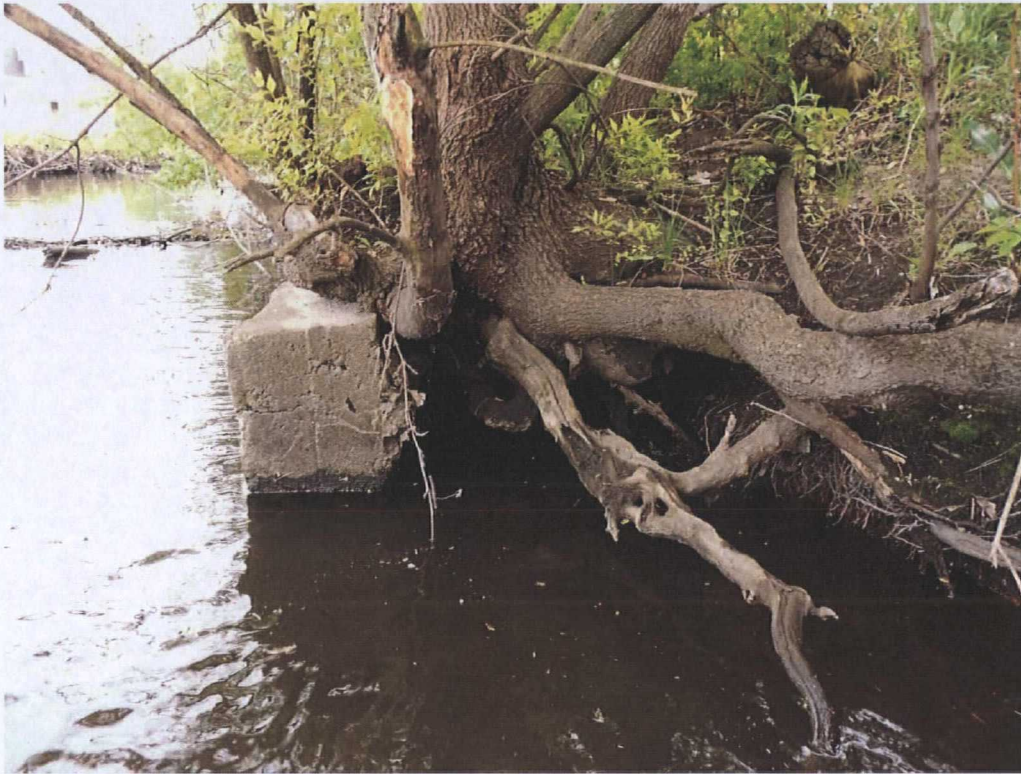
Severe bank erosion behind north end of wall

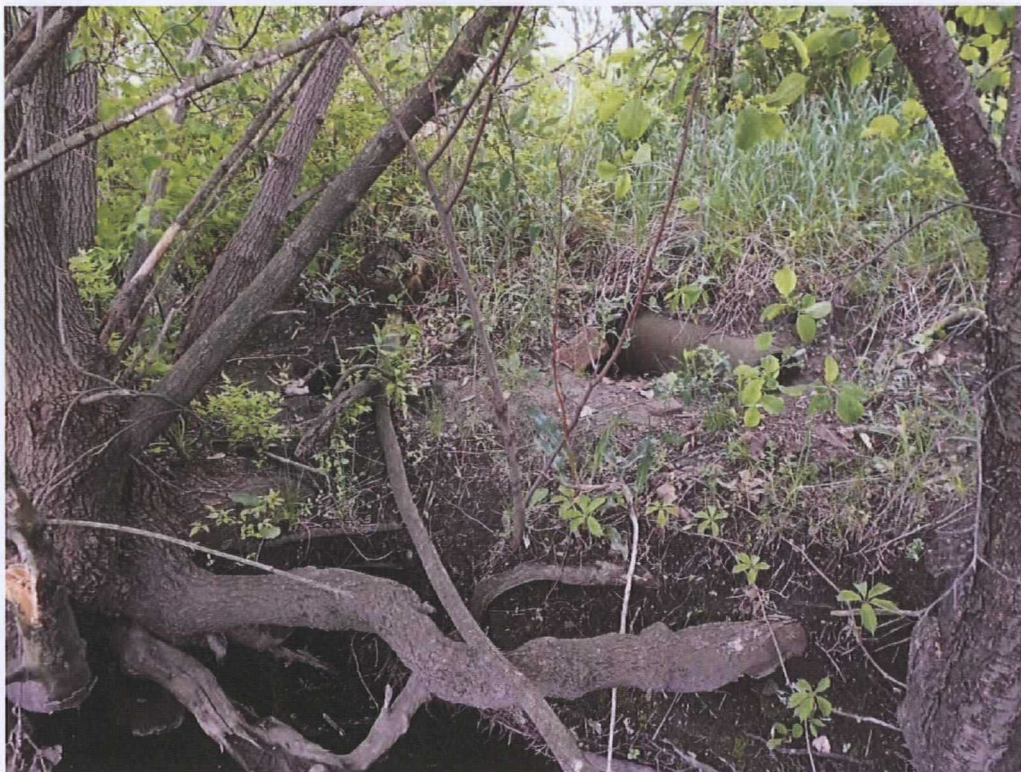
Sink hole with exposed steel pipe in the northwest bank area

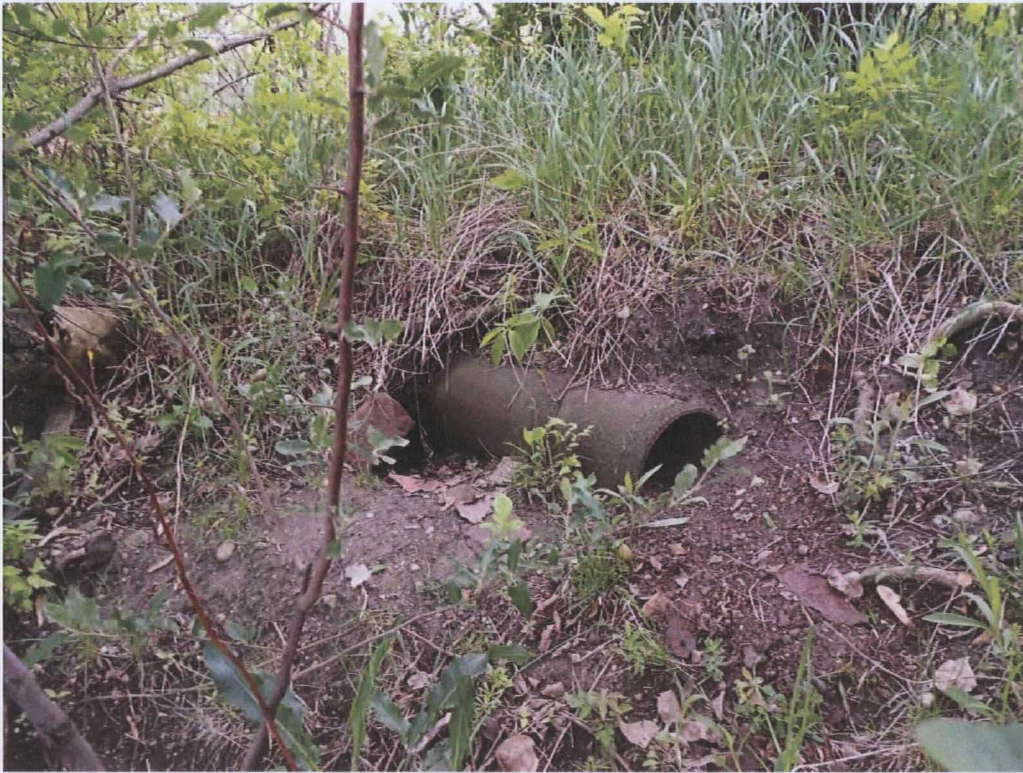
Close-up of sinkhole and steel pipe

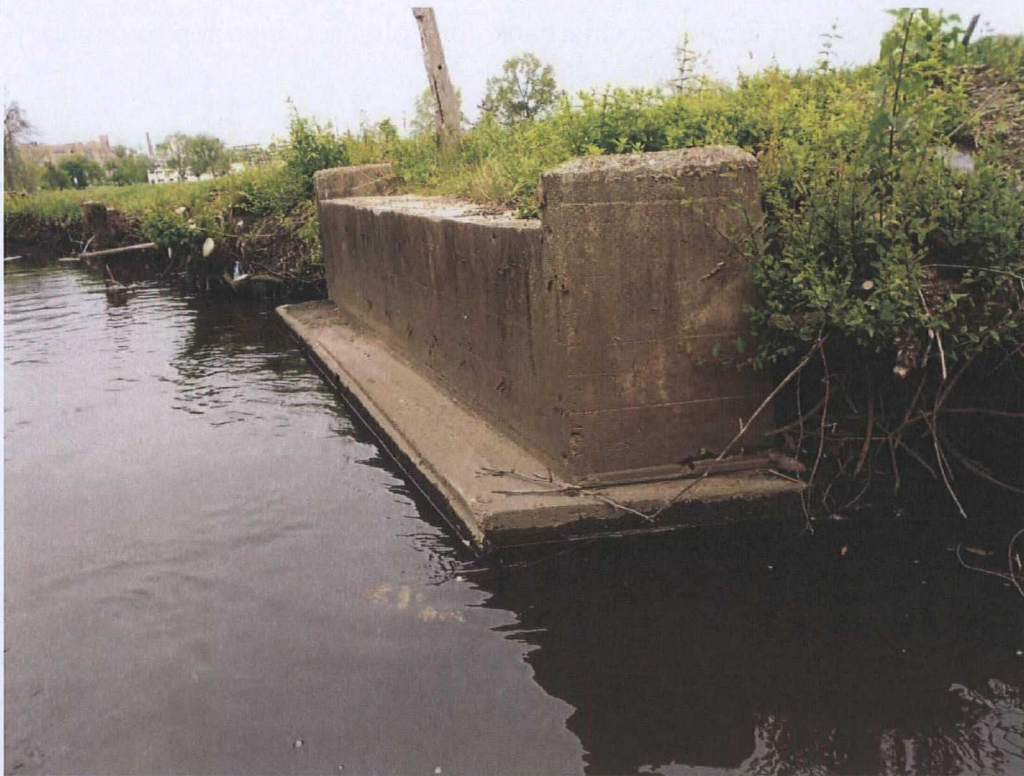
- Severe bank erosion was noted around the northeast, southeast and northwest and minor erosion in the southwest, however no undermining was detected.
- A severely spalled concrete post remains in the northeast and there is a failed concrete post on the southwest slope area.
- The concrete is in fair condition with shallow spalling and scaling as well as scattered cracking noted.

View of east abutment from upstream channel

- Because the structure has been abandoned, it can likely be removed. However, it is recommended that the City of Kalamazoo be consulted to verify as it may be feasible to salvage the abutments for a future crossing at this location.

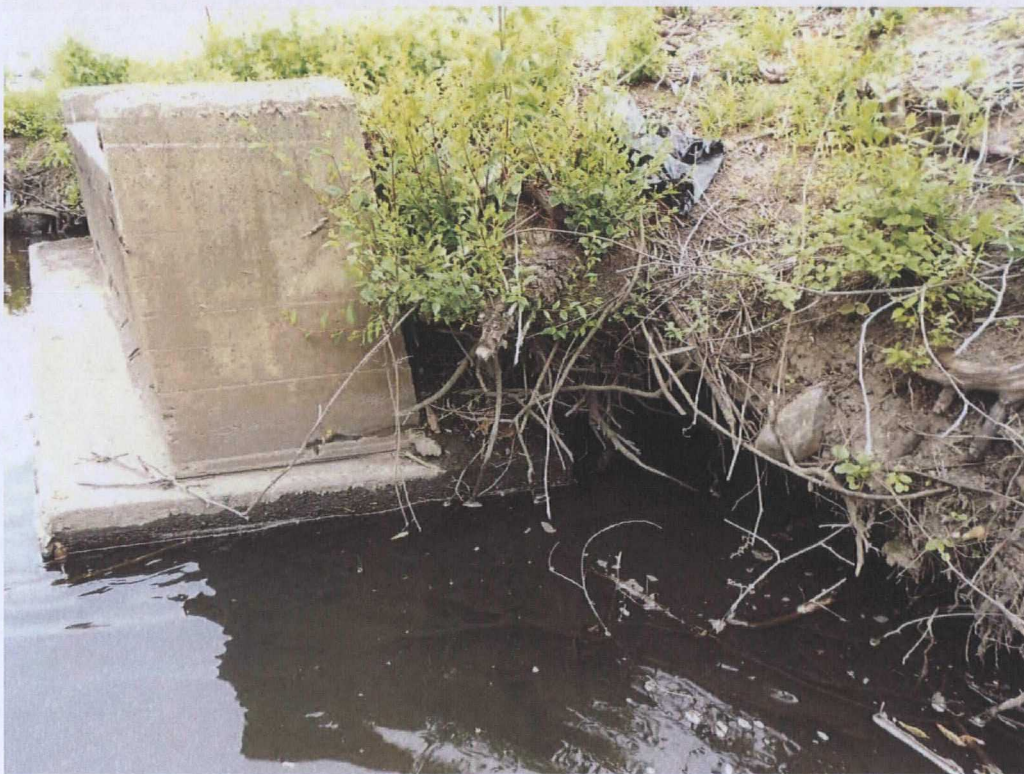
Severe erosion behind southeast abutment

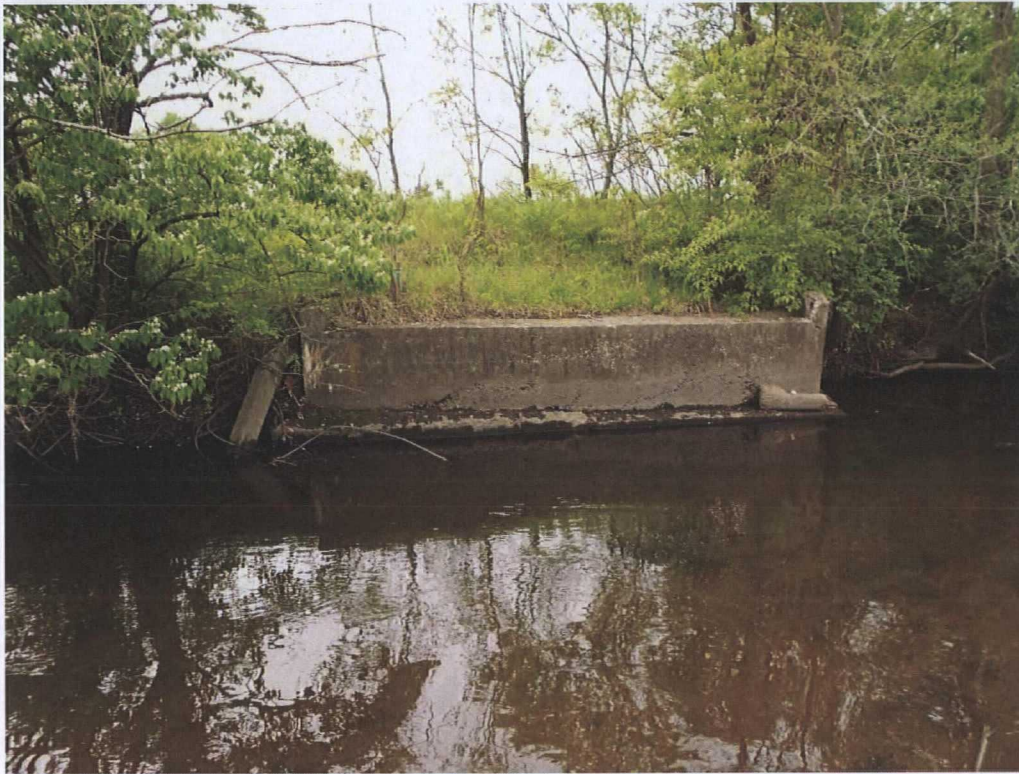
View of the west abutment from the channel
